Metal Roof Restoration

- Category:** Water-proofing & Insulation
- Customer:** Residential Building
- Project:** Roofing repair and installation of a spray polyurethane foam-based (SPF) roof system.
- Products:** DuraTite® CC2.5, DuraTite® 1395

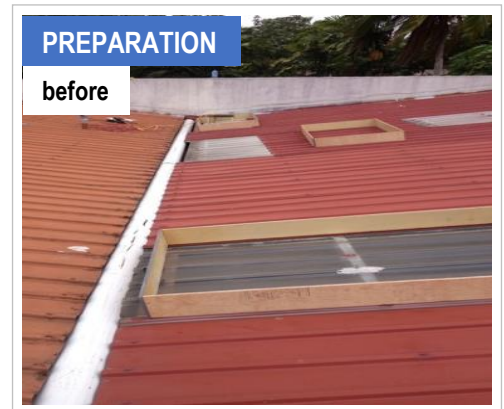
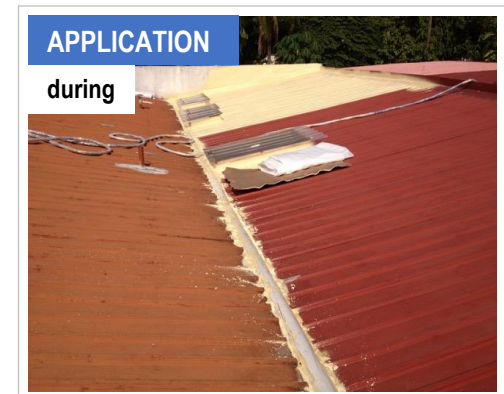
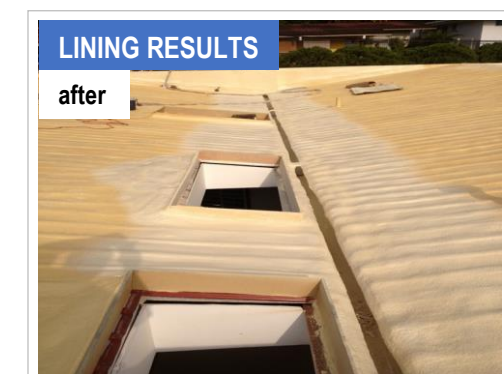
Panama Linings S.A., a Rhino Linings® applicator, recommended a combination of DuraTite CC2.5 and DuraTite 1395 for a watertight, energy efficient system, durable enough to extend the life of the roof and provide long term benefits against constant Sun exposure. Preparations begin with a pressure wash of the metal substrate to remove any loose paint, mold, grime, dust and dirt creating a clean surface for coating.

Next, 4 inch PVC piping is connected to the original drain pipe to reach across the entire canal. Skylights were raised 10 inches from the roof and replaced with polycarbonate. DuraTite CC2.5 was then spray-applied 1 inch thick covering the entire roofing structure.

Silicone coating DuraTite 1395, was then fluid applied over the SPF. The solar reflective properties of the white pigment used in DuraTite 1395 play an essential role in keeping the internal temperatures from reaching too high when the Sun is most intense. The white pigmented protective shell that is formed, works to distribute heat evenly across the surface of the roof by scattering sunlight.

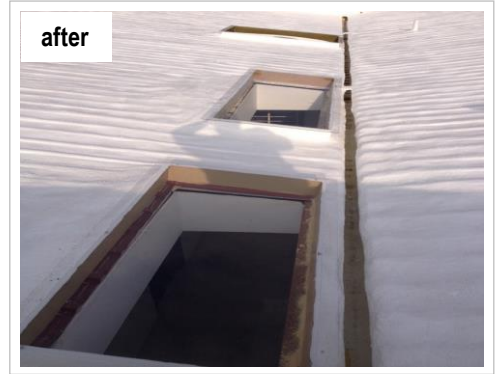
The applicator was able to extend the life of the roof, remedy the drainage issue and provide the insulation and durability the customer needed. According to the resident the system has been installed for over 3 years with no required maintenance and in home temperature has dropped 25%.
